ST LUKE'S, OLD STREET CONSERVATION PLAN

PREPARED BY

PURCELL MILLER TRUTTON

FEBRUARY 2000

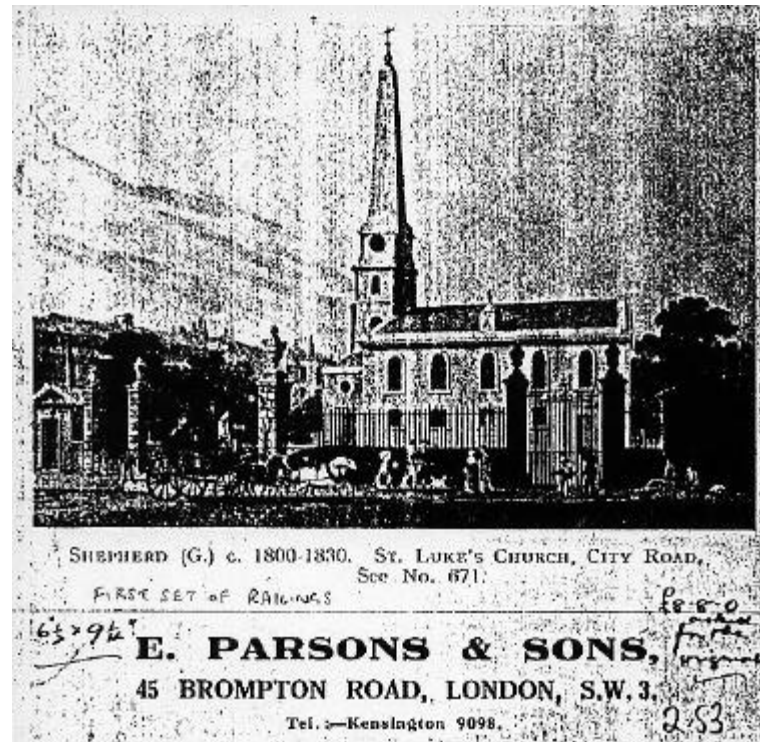
Figure 10

The wrought iron railings (separately Listed from the church) which surround the Churchyard, as well as the main entrance of the Burial Ground to the North, have been restored and are of historical significance although the present railings are the second set to be erected, replacing the original boundary structure in 1852. The general appearance of the first set of gates, piers, urns, walls and railings is known from Shepherd's c.1800-1830 engraving which also indicates previous pedimented structures in the South East and South West corners. Some evidence of these previous structures may exist underground and if so, will be quite vulnerable (**figure 10**).

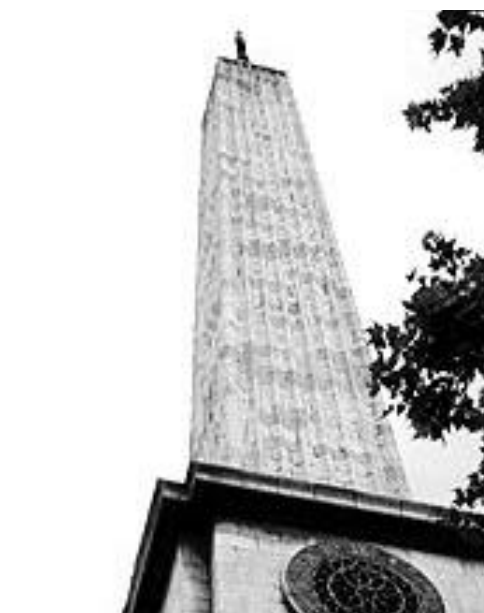
Figure 34

The reparability of the exterior fabric needs further detailed assessment but it appears to be viable, and there is a need for repair and reinstatement to proceed on the basis of minimum necessary replacement of existing fabric (**figure 34**). The repairs to the existing

stonework recommended by Resurgam in their recent report (1999) are of this nature and they should be carried out. There appears to be sufficient physical and photographic evidence to accurately reinstate areas of stonework lost (principally the East gable and parapets) in the 1959 partial demolition (**figure 35**). The original joint pattern should be respected as closely as possible even if this has distorted subsequently.

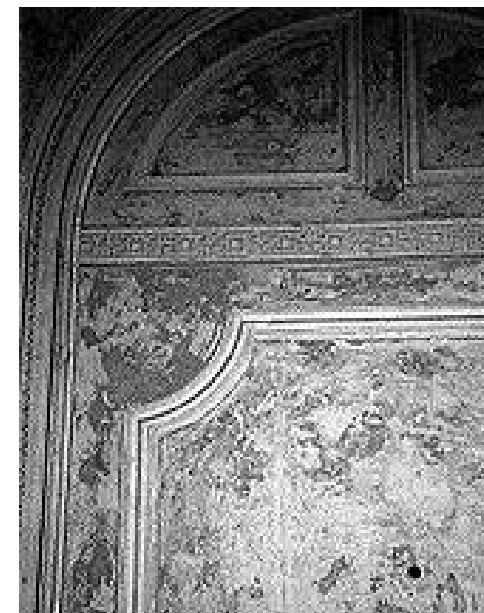
Figure 41

modern replacements (c. 1930's gypsum/fibrous plaster) inconsistent with the documented existence of exterior domes as well as with the interior form of the entrance vestibule (**figure 41**). It is unclear, however, as to how the domes were finished: although logic suggests that they may have included some form of glazing, it is known that in later years the domes were lead-covered.

It is important that planning for redevelopment includes physical investigation to establish as far as possible the original form of the staircase hall ceilings. Assuming that the premised replacement of domes with flat ceilings proves correct, and evidence of the original form exists in the structure above, they could be reinstated in a more sympathetic manner.

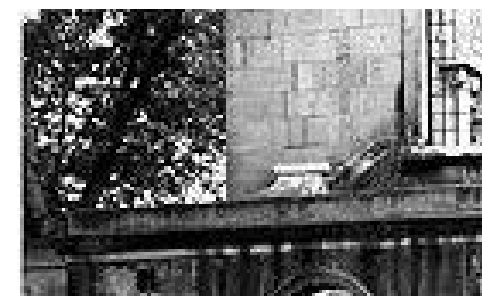
Figure 61

The northeast vestry forms an integral part of the original church (**figure 61**), and aside from the entrance vestibule and staircase halls, presents the only partially-surviving interior of St Luke's.

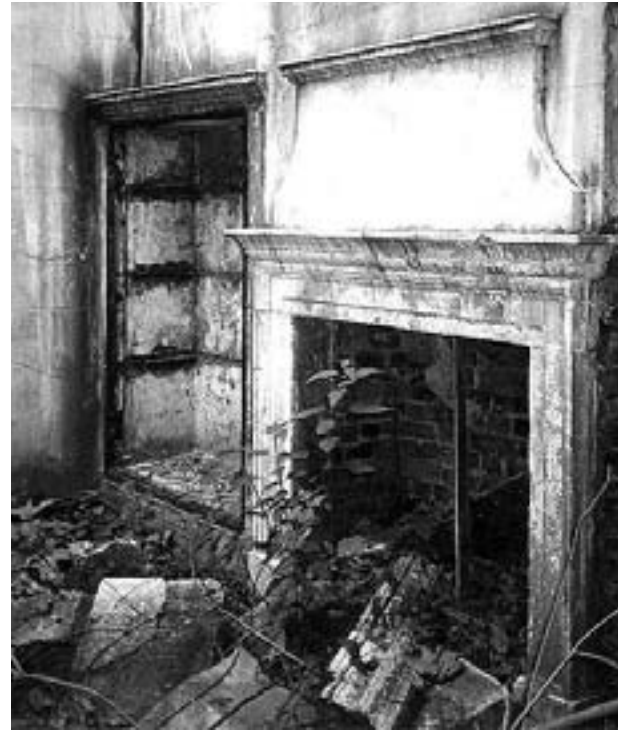
Figure 63

Although the vestry clearly suffered from the same severe subsidence which led to the dismantling of the church - the north wall was simply rendered to re-establish a vertical line - the external fabric is intact and could be repaired rather than replaced (**figure 62**). However if the vestry is to be removed and rebuilt the walls should be fully recorded and original materials either re-incorporated or stored on site (**figure 63**).
