ST LUKE'S, OLD STREET CONSERVATION PLAN

PREPARED BY

PURCELL MILLER TRUTTON

FEBRUARY 2000

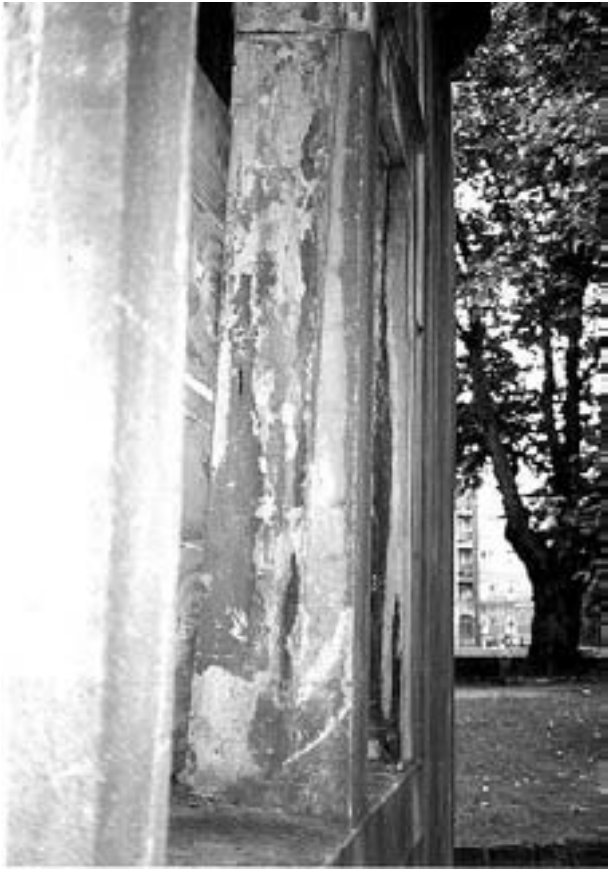
Figure 62

Although the vestry clearly suffered from the same severe subsidence which led to the dismantling of the church - the north wall was simply rendered to re-establish a vertical line - the external fabric is intact and could be repaired rather than replaced (**figure 62**). However if the vestry is to be removed and rebuilt the walls should be fully recorded and original materials either re-incorporated or stored on site (**figure 63**).
